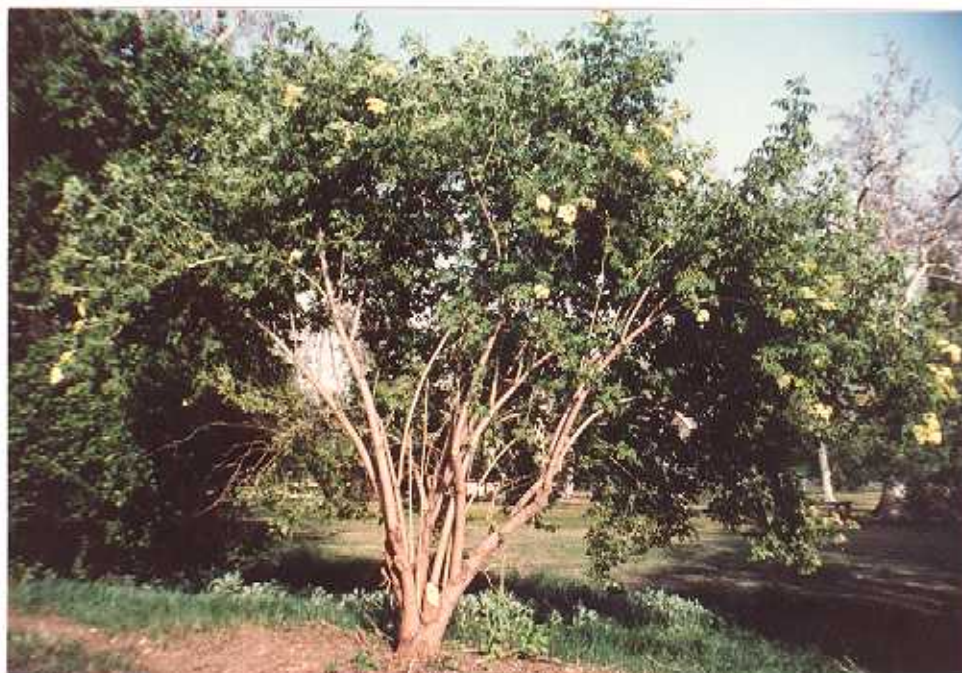
Figure 36. Recently pruned *Sambucus* adjacent to Bartlett Park (Co.) on the Tule River, Tulare Co. (Site #35); VELB exit holes were present.

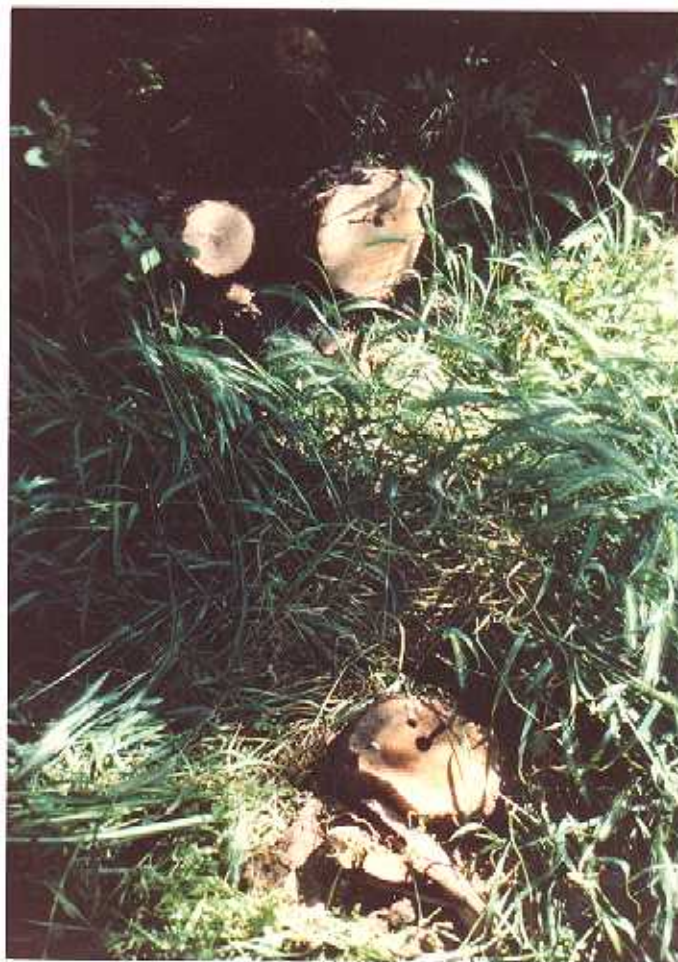
Figure 37. Recently cut *Sambucus* logs at Reading Island Recreation Area (BLM) campsite on the Sacramento River, Shasta Co. (Site #61); VELB exit holes were present.

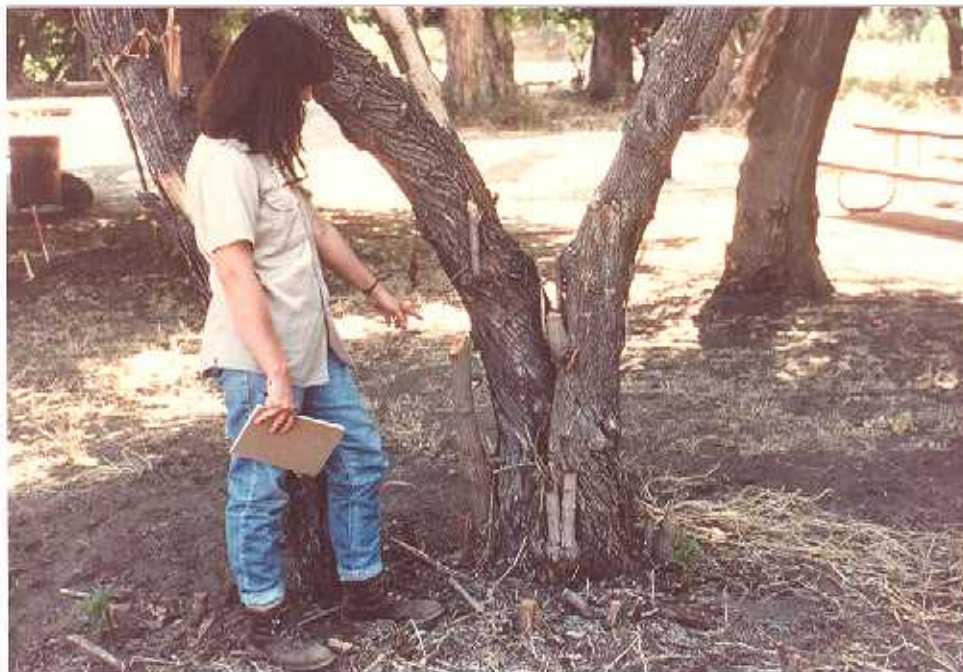
Figure 38. Cutting damage to *Sambucus* at McHenry Avenue Park (COE) picnic area on the Stanislaus River, San Joaquin Co. (Site #223); VELB exit holes were present.

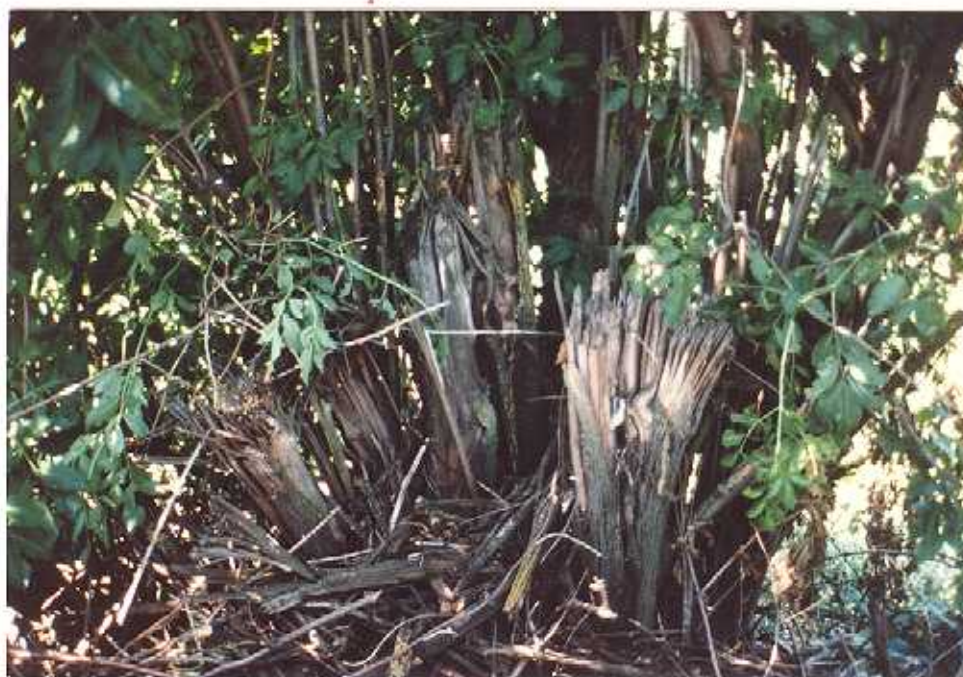
Figure 39. Old, splintered *Sambucus* stems and trunks surrounded by young shoots (Site #89).

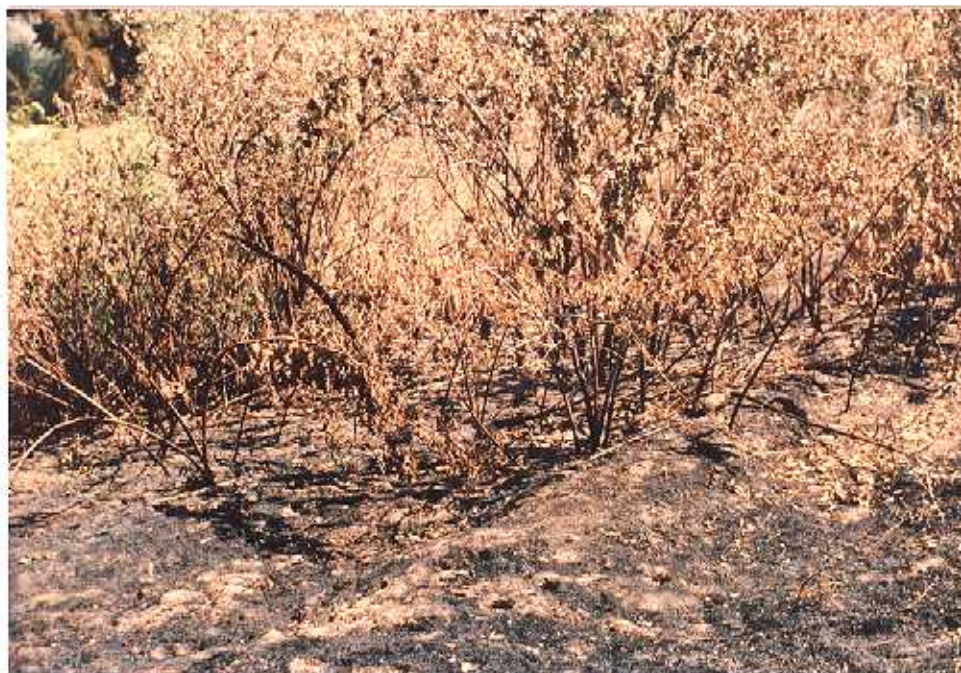
Figure 40. Burned *Sambucus* grove (Site #210).

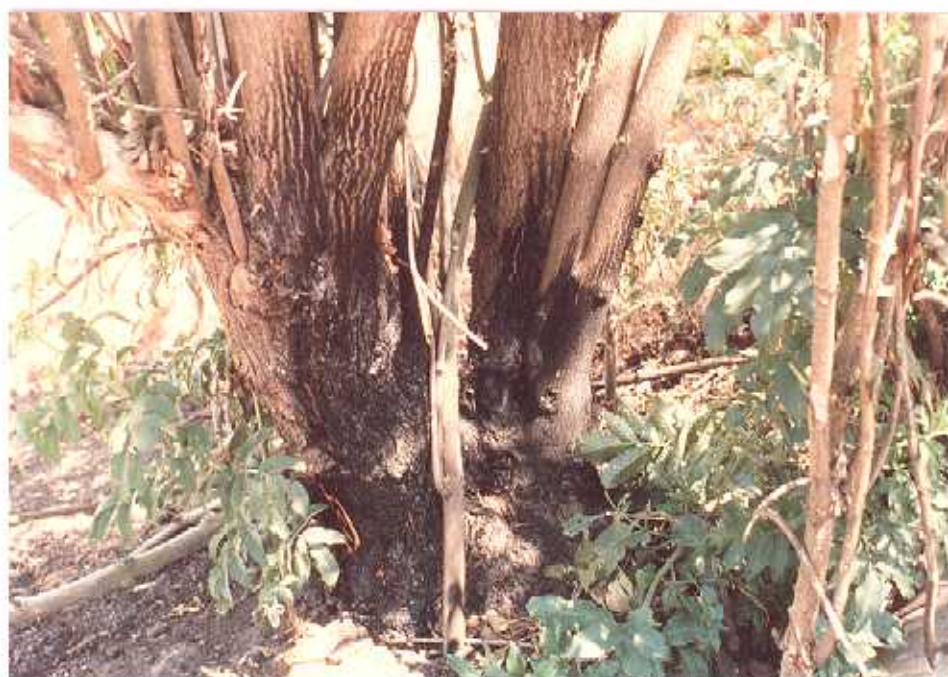
Figure 41. Burn scars on *Sambucus* trunk (Site #205).
